User Guide

CAN-Bus Troubleshooting

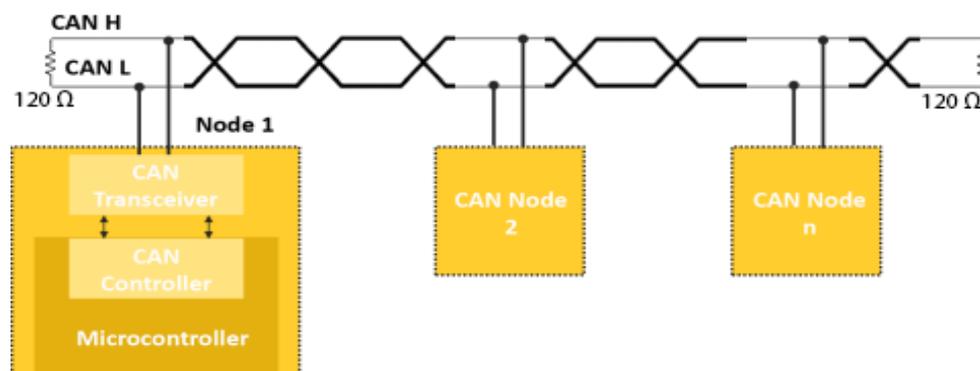
This test measures the series resistance of the CAN data pair conductors and the attached terminating resistors.

1. Turn off all power supplies of the attached CAN nodes.
2. Measure the DC resistance between CAN H and CAN L at the middle and ends of the network.
 - The measured value should be between 45 Ω and 65 Ω . The measured value should be nearly the same at each point of the network.
 - If the value is below 45 Ω .
Ensure that there is no short circuit between CAN H and CAN L Line, not more than two terminations, no faulty transceivers in the line.
 - If the value is above 65 Ω .
Ensure that there is no open circuit between CAN H and CAN L Line, and check whether the line has two 120 Ω resistances or not.

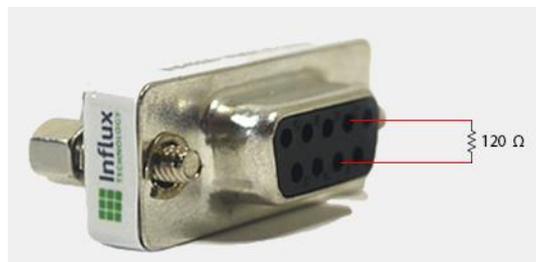
If there is no existing termination for the can nodes, we can use an external DB9 120 Ohm terminal resistor which can be directly placed in a can network. It is having a 120 Ohm terminal resistor between the CAN High / CAN Low pins.

Influx branded 120 Ohm termination adapter. **Highly recommended** to terminate the CAN bus

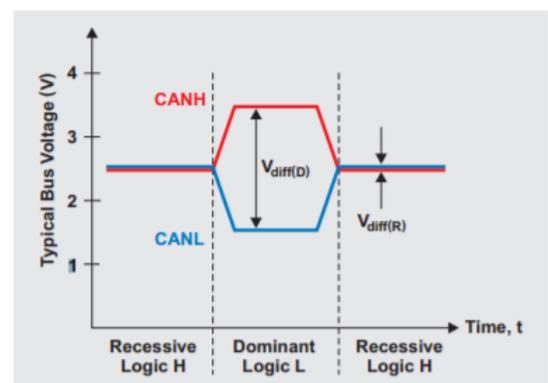
1. Turn on all supplies.
2. Stop all network communication.
3. Measure the DC voltage between CAN High and Ground
4. Measure the DC voltage between CAN_ Low and Ground

Normally the voltage should be between 2.0 V and 4.0 V.

If it is lower than 2.0 V or higher than 4.0 V, it is possible that one or more nodes are faulty.

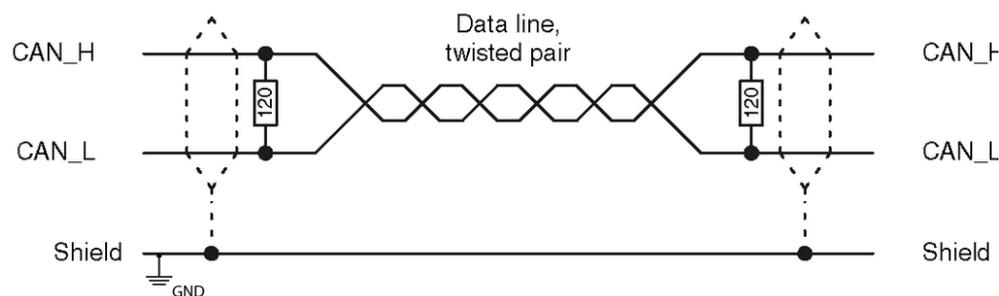
In a vehicle Shield should be grounded directly to vehicle ground, using wire conductor to one single point, with lowest impedance connection possible, preferably close to the centre of the network.

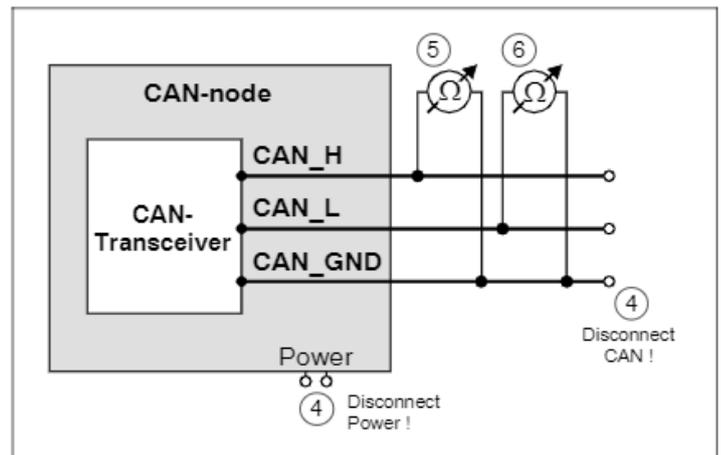
1. Disconnect the node from the network. Leave the node unpowered (see figure below).
2. Measure the DC resistance between CAN_H and CAN_GND (see figure below).
3. Measure the DC resistance between CAN_L and CAN_GND (see figure below). Normally the resistance should be between 1 M S and 4 M S or higher. If it is lower than this range, the CAN transceiver is probably faulty.
